Aircraft Accident Investigation Bureau

Interim Investigation Report on

**Accident to the B737-8 (MAX) Registered ET-AVJ operated by
Ethiopian Airlines**

Report No. AI-01/19

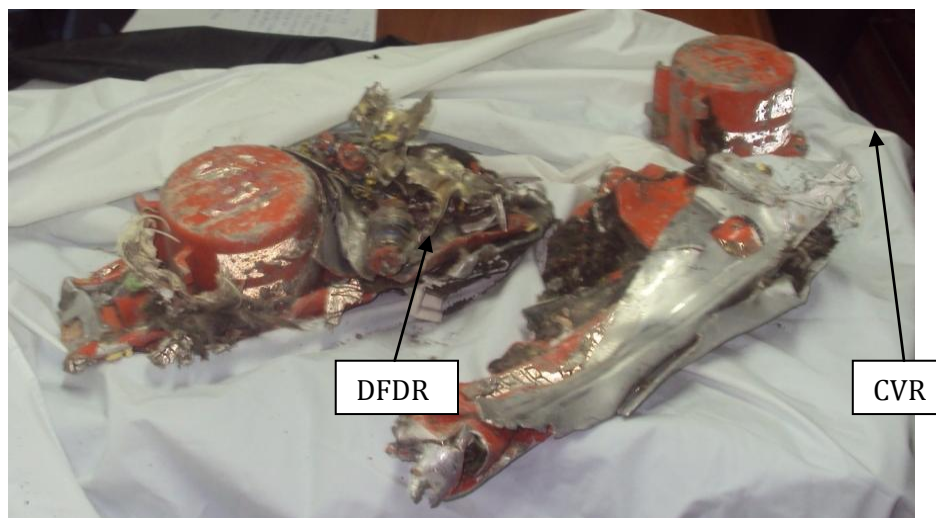
FIGURE 24: DFDR AND CVR AS DISCOVERED ON THE ACCIDENT SITE.

The Aircraft was equipped with a Digital Flight Data Recorder (DFDR) and Cockpit Voice Recorder (CVR), which were located in the aft cabin and aft cargo hold (respectively) section of the aircraft.

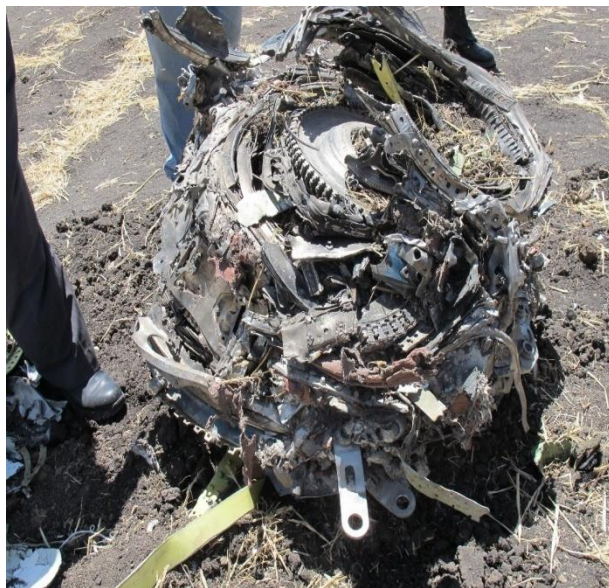
FIGURE 36: R/H ENGINE - S/N 602695 - CORE

The predominant feature of the deformation of the entire remaining core was axial deformation.

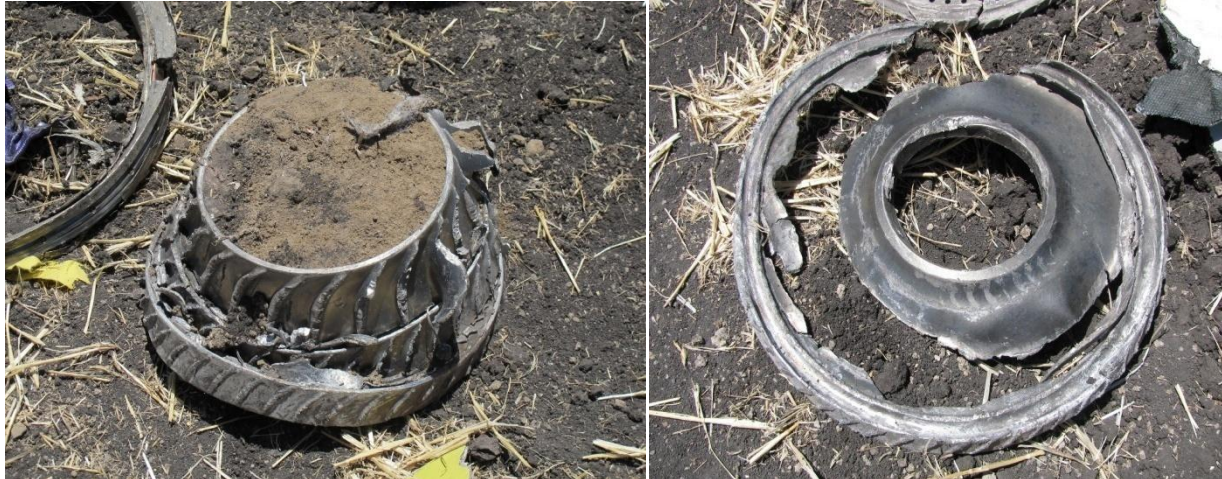
FIGURE 40: - R/H ENGINE - S/N 602695 – HPC STAGES 1 TO 3 FIGURES 41:- R/H ENGINE - S/N 602695 – HPC STAGE 7

The HPC case was fractured and a portion of it remained with the core and the HPC stages were separated from the core. The 1st, 2nd and 3rd stage blisks were found together and were missing their airfoils. The 4th, 6th, and the 8th to 10th stages were not found. The 5th stage was found separately, and it was also missing its airfoils. The 7th stage web was fractured circumferentially. The stator sections could not be identified.

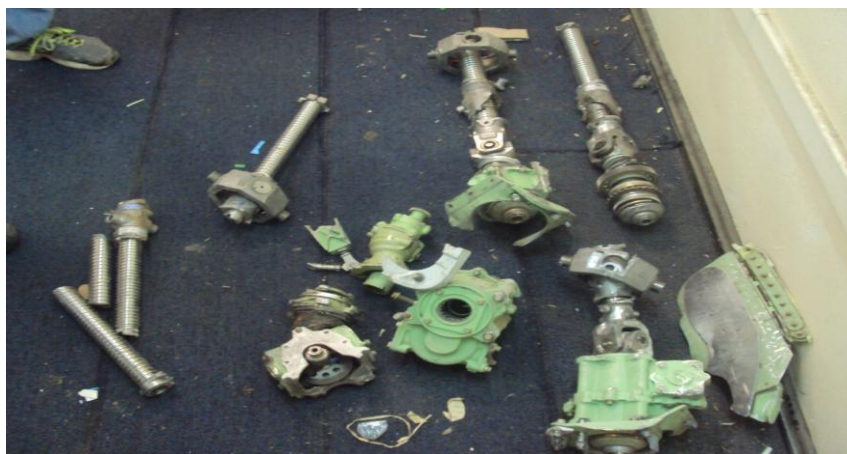
FIGURE47: TRAILING EDGE FLAP TRANSMISSIONS AND BALL SCREWS

During the examination of the wreckage pile located at the Addis Ababa airport AIB store, the Airworthiness group identified a total of 4 (including the ones identified at the impact site) trailing edge flap transmissions (there are 8 total); three of these had the ball nut and gimbal still attached.

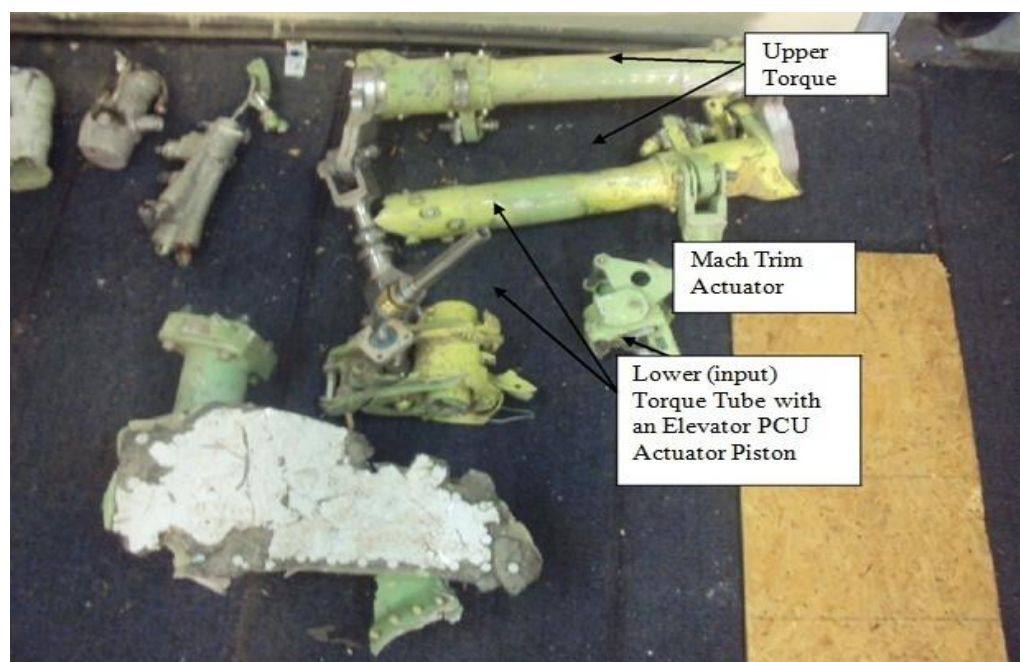
FIGURE55: ELEVATOR PCU ACTUATOR PISTON

The Airworthiness group located components from the elevator control system within the wreckage pile located at the Addis Ababa airport property.

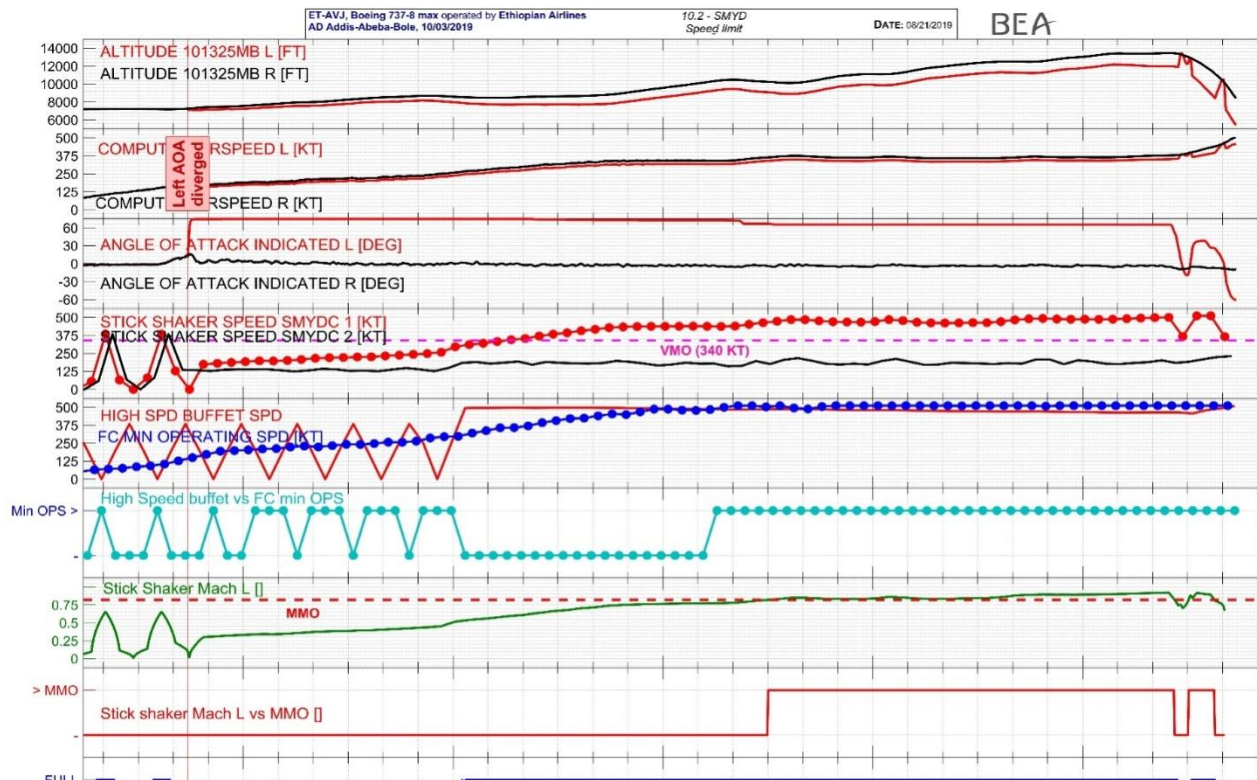
FIGURE 64: SMYD COMPUTED SPEEDS LIMITS

At 5 h 41 min 17 s, SMYDC1 computed FC minimum operational speed values greater than High speed values. Both values were computed by the same computer SMYDC 1.

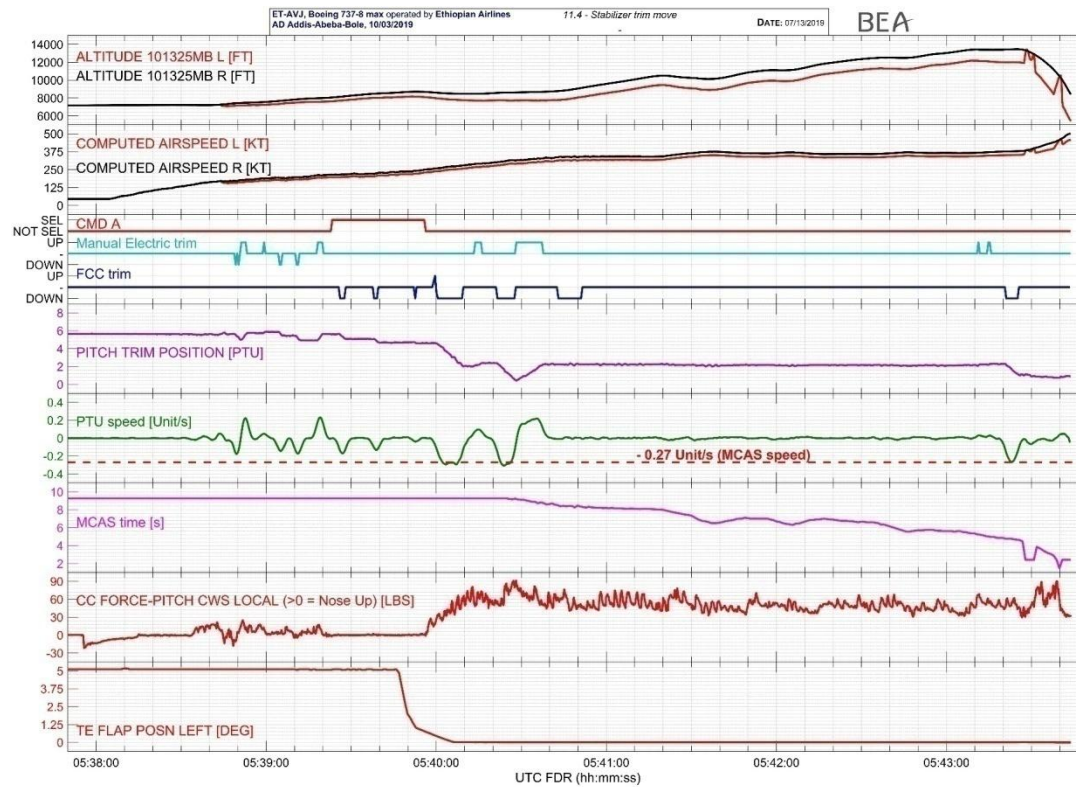
FIGURE 65: STABILIZER COMMANDED MOVES

During the beginning of the flight, several manual electrical trim inputs were recorded. These inputs limited the force the captain applied to the control column. Between the lift off and the engagement of CMD A, the stabilizer moved between 4.9 and 5.9 units. When A/P was engaged, the stabilizer was at 5.6 units.
