Aircraft Accident Investigation Bureau

Interim Investigation Report on

**Accident to the B737-8 (MAX) Registered ET-AVJ operated by
Ethiopian Airlines**

Report No. AI-01/19

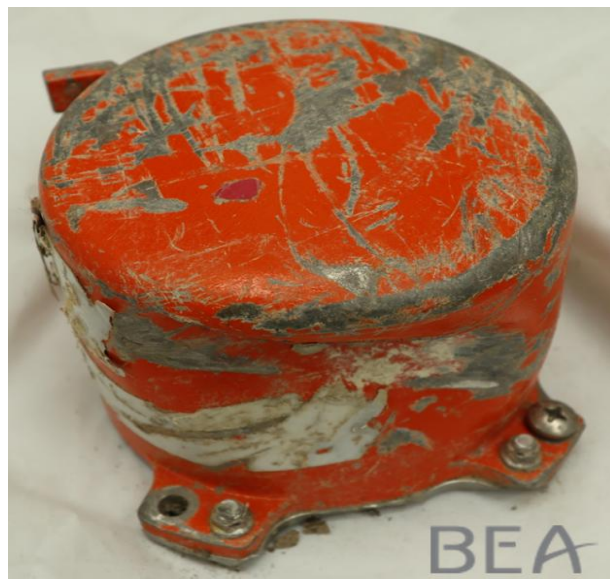
FIGURE 30: CVR CSMU

On 11 March 2019, the CVR was recovered from the accident site by the AIB. The CVR CSMU was transported to the BEA recorder facility for data downloading. The CMSU was found separated from the chassis during wreckage recovery. The read-out was performed by BEA under the authority of the Ethiopian Accident Investigation Bureau (AIB), with the observation of the National Transportation Safety Board (NTSB) of United States of America.

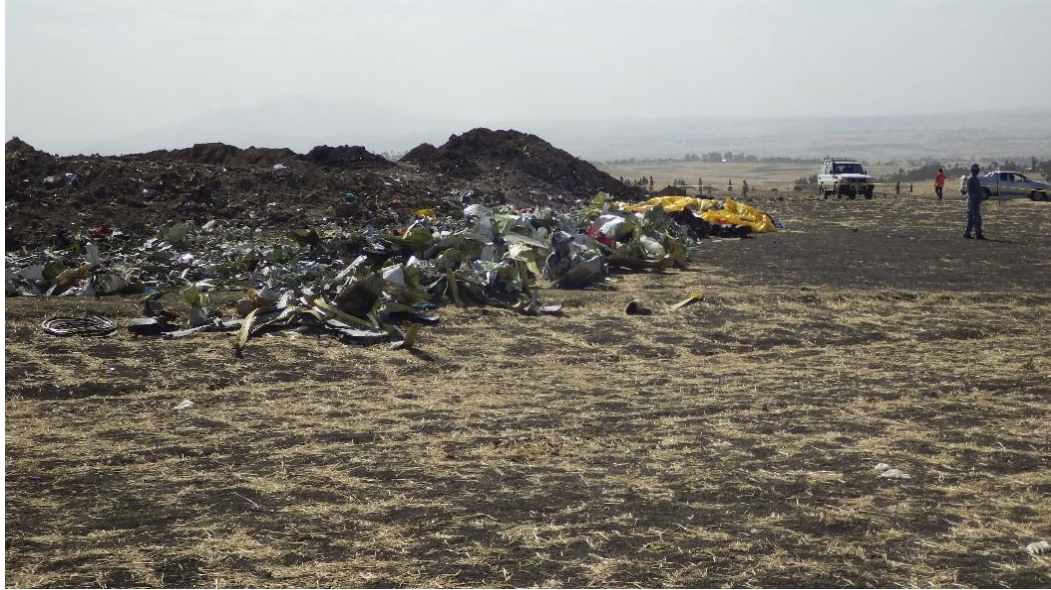
FIGURE 34: ACCIDENT SITE

The Aircraft impacted terrain at a farm field and created a crater approximately 10 meters deep (last aircraft part found) with a hole of about 28 meters width and 40 meters length. Most of the wreckage was found buried in the ground; small fragments of the aircraft were found

scattered around the site in an area by about 200 meters width and 300 meters long. The damages to the aircraft are consistent with a high energy impact.

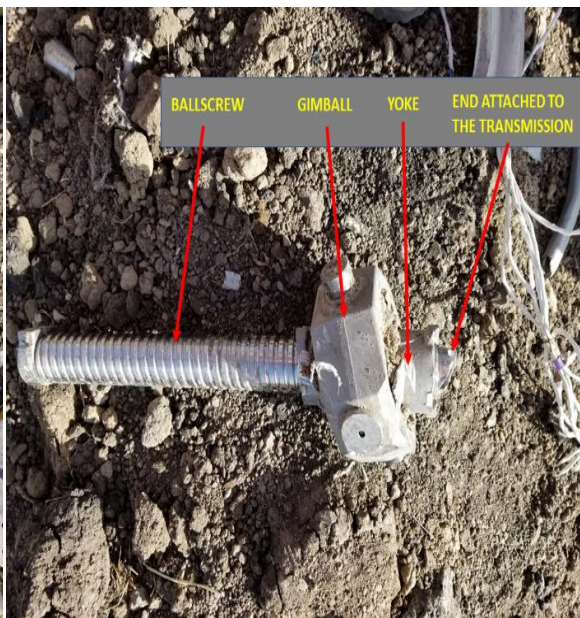
FIGURE46: FLAP TRANSMISSION

The installed location of each unit has not been identified. The position of each gimbal is consistent with the flaps in the fully retracted position.

Again, all three were found in the fully retracted position. There was one additional transmission portion that was found as well as three ball screw segments. All examined damage appears consistent with high energy impact.

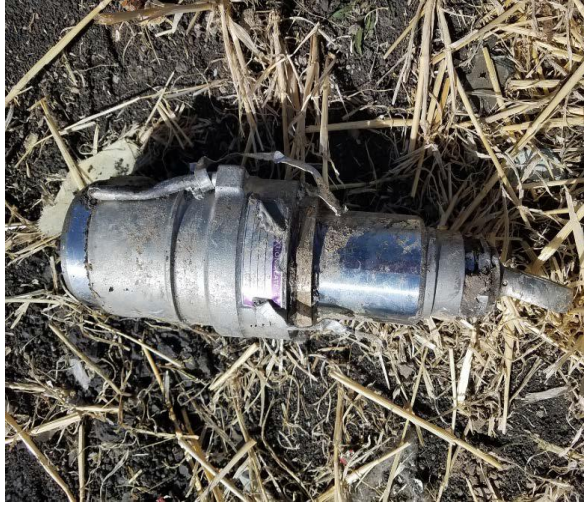
FIGURE 48: SLAT ACTUATOR (POSITION UNKNOWN)

Two of the 8 leading edge slat actuators were photographed (see Figures below) at the impact site. The installed location for each actuator has not been identified. The actuator position, as photographed, is in the fully retracted position.

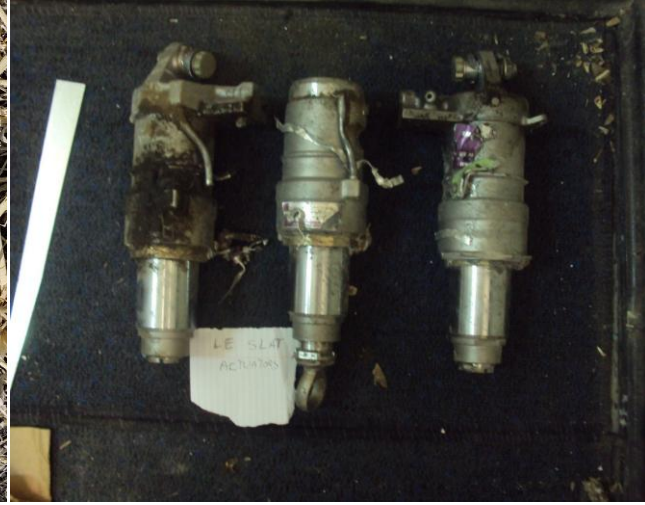
FIGURE 49: LEADING EDGE SLAT ACTUATORS

During the examination of the wreckage pile located at the Addis Ababa airport AIB store the Airworthiness group identified a total of three leading edge slat actuators at the impact site. The actuator position, as photographed, are in the fully retracted position,

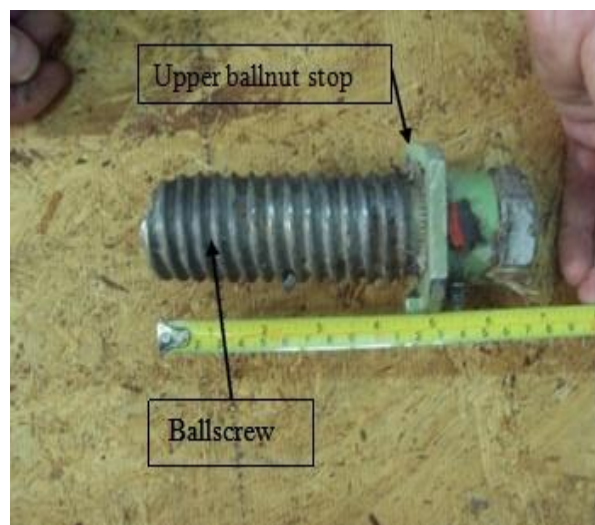
FIGURE53:UPPER BALLSCREW SEGMENT

Examining the fracture surfaces, the upper screw segment fits with the fracture face just inside the ballnut giving a measurement between the stops on the ballnut and the upper ballnut stop of ~5". Referencing Boeing document D251A122 (737NG Control Position Data), this measurement equates to a stabilizer trim setting of 1.5 degrees Airplane Nose Down (AND) or an indicated position of 2.5 units of trim. Although the data is for the 737NG, the position of the MAX stab trim holds the same relationship. According to Boeing:

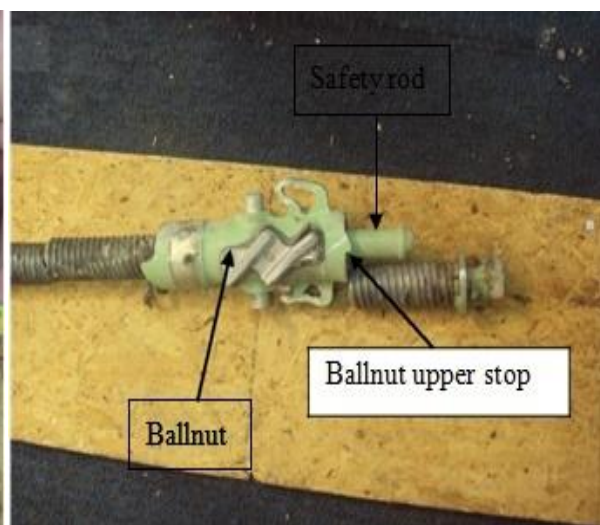
FIGURE 54: BALLNUT AND UPPER BALLSCREW SEGMENT

The figure below shows the relationship of the ballnut position along the ball screw. There is a safety rod which acts as a secondary load path should the ball screw fracture in service for any reason. It is attached to a separate set of secondary gimbals below the primary support gimbals on the primary brake housing and to the top of the ball screw. Figure 54 shows the safety rod and that it protrudes out from the ball nut. However, the fracture faces on the 5" long upper screw portion (note the measurement in Figure 53) match those found near the ballnut upper stop. This is consistent with the safety rod being pulled out several inches prior to final fracture.

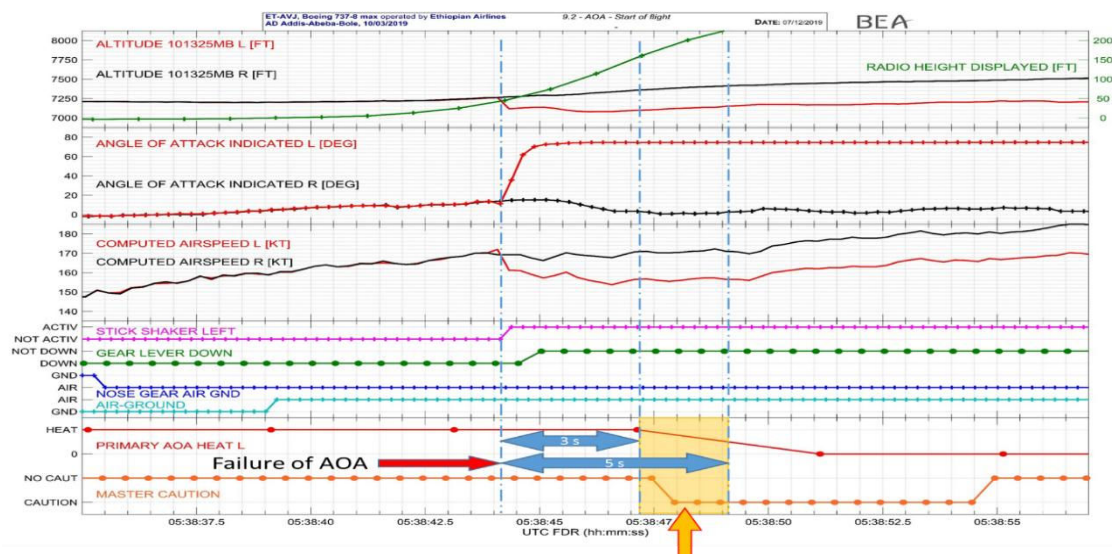
AOA VALUES DURING THE BEGINNING OF THE FLIGHT

At 5 h 38 min 48 s, a master caution triggered. From that time, the primary AOA heat LH recorded values underlined a failure of the vane heating (first recorded OFF value at 5 h 38 min 51s, sampling rate of the parameter: 0.25 Hz). The reason of the master caution was the anti-ice left alpha vane indication.

The recorded computed airspeed values and the recorded corrected pressure altitude values were computed with the signal coming from the AOA sensor resolver No2. Their values were consistent with the shape of the LH AOA recorded values (for both parameters, an increase followed by a decrease). The triggering of the stick shaker underlined that the signal coming from the resolverNo1 matched also the LH AOA recorded values. Due to the way the AOA values were recorded, both resolvers of LH AOA sensor provided similar values. The failure impacted the signals provided by both resolvers of the LH AOA sensor.

According to the description provided in §1.6.3.3 it took between 3 to 5 s between the AOA heat failure and the triggering of the associated master caution. The LH AOA heat failure triggered at a time consistent with a single event leading to both heat failure and erroneous values from both resolvers at the same time.

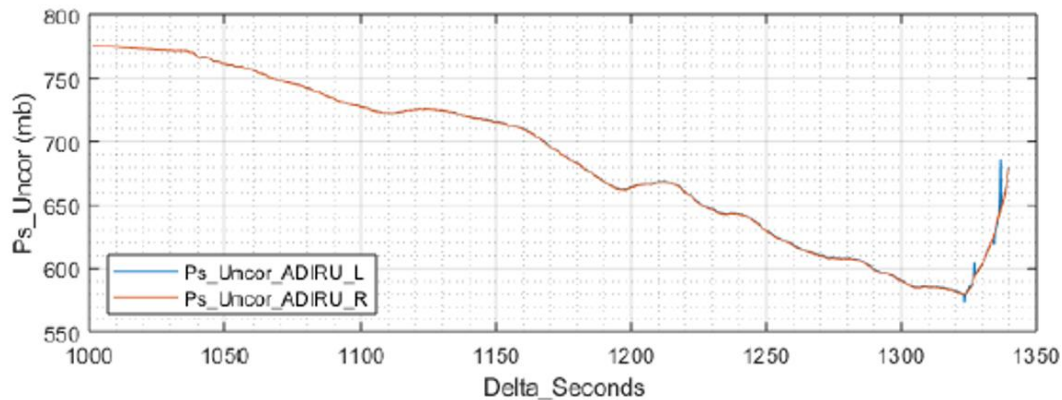
FIGURE 58: UNCORRECTED STATIC PRESSURE COMPUTED BY THE AIRPLANE MANUFACTURER

The airplane manufacturer recomputed the uncorrected static pressure for both sides, with the recorded LH and RH AOA values.

Uncorrected static pressure values from both sides were identical. The difference between the LH and RH side corrected pressure values were therefore only due to the AOA correction.

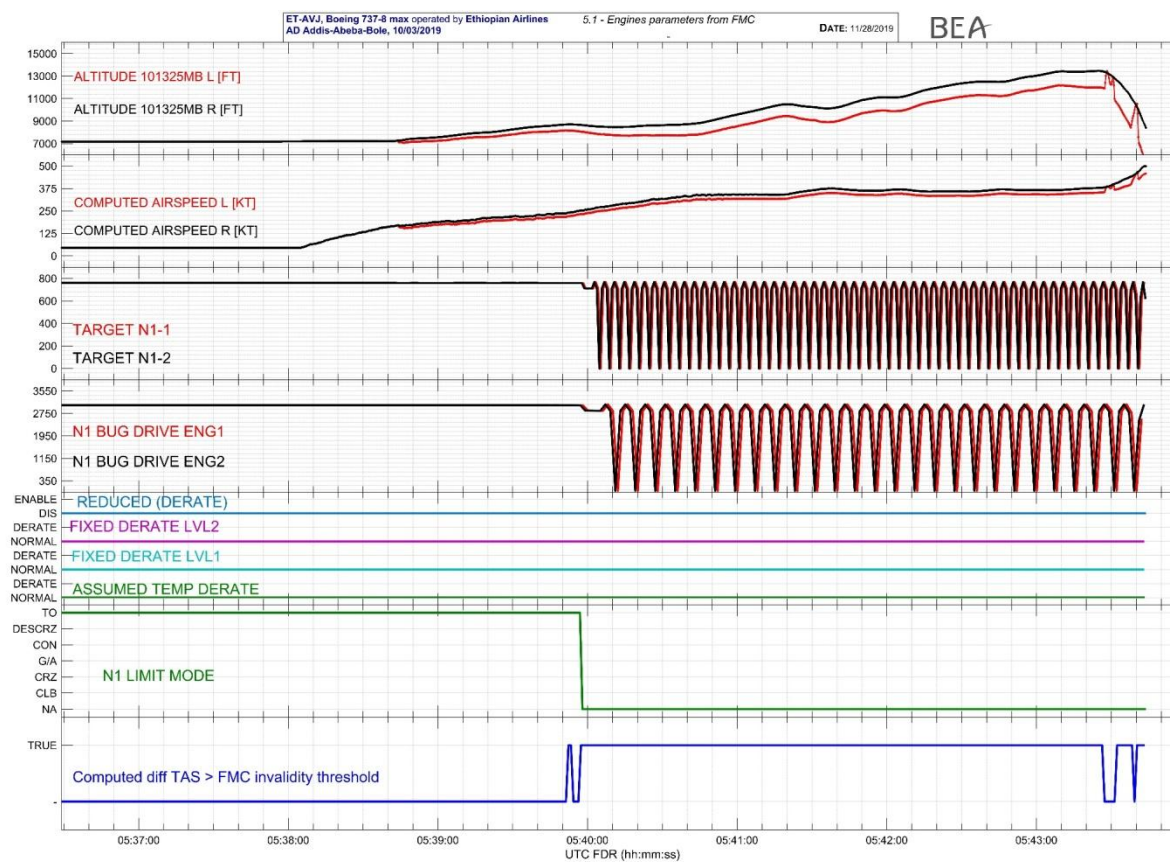
FIGURE60: FMC PARAMETERS FOR THE ENGINES

For the takeoff phase, the N1 limit mode was the TO mode and the N1 recorded values corresponded to 95% of $N1_{max}$. At 7,000 ft of elevation, it indicates that the take-off was performed with Max Takeoff Thrust. Indeed, at 7,000 ft of elevation, between 15°C and 20°C, the Max Takeoff thrust corresponds to 95% of N1.

Note: At 5 h 39 min 52 s, the difference between the computed LH and RH TAS values reached the threshold value used by FMC to detect inconsistency. Whatever the impact of these 2 samples might have had, no information of invalidity can be recorded inside the FDR recorded data.

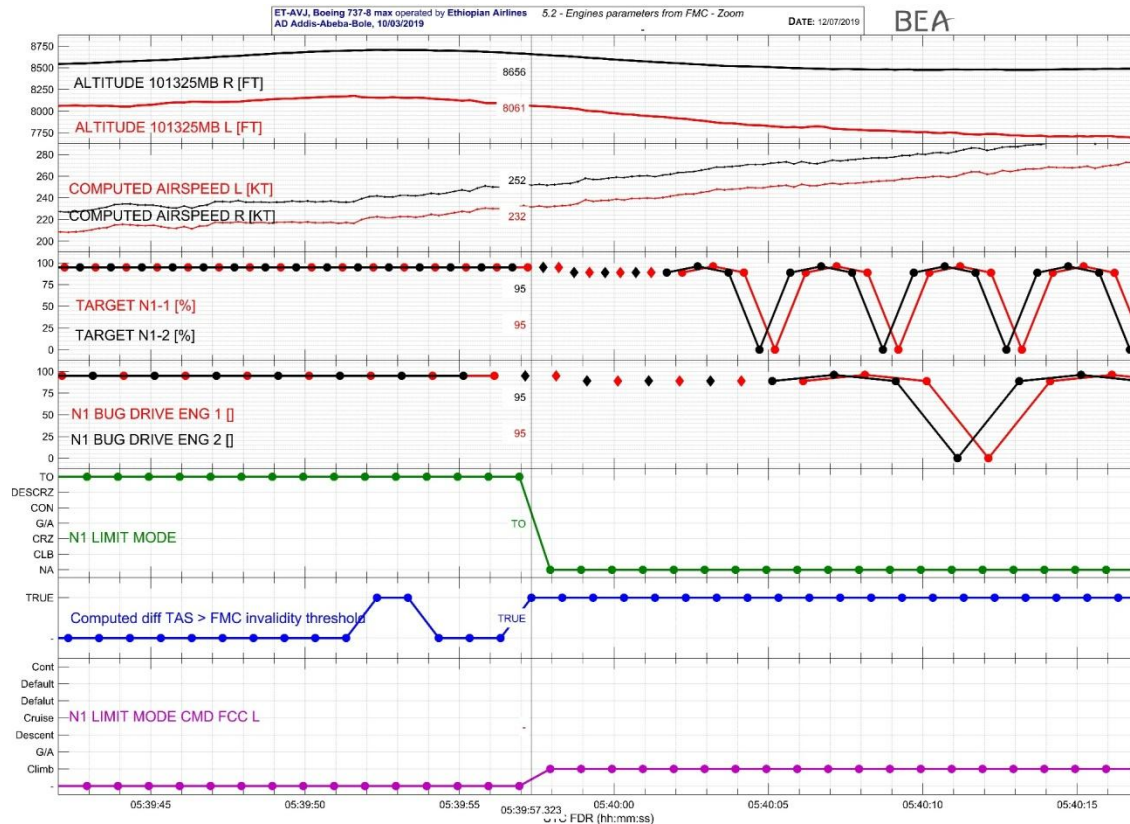
FIGURE 61: FOCUS ON INVALID N1 DATA FROM FMC

On The Figure 61:

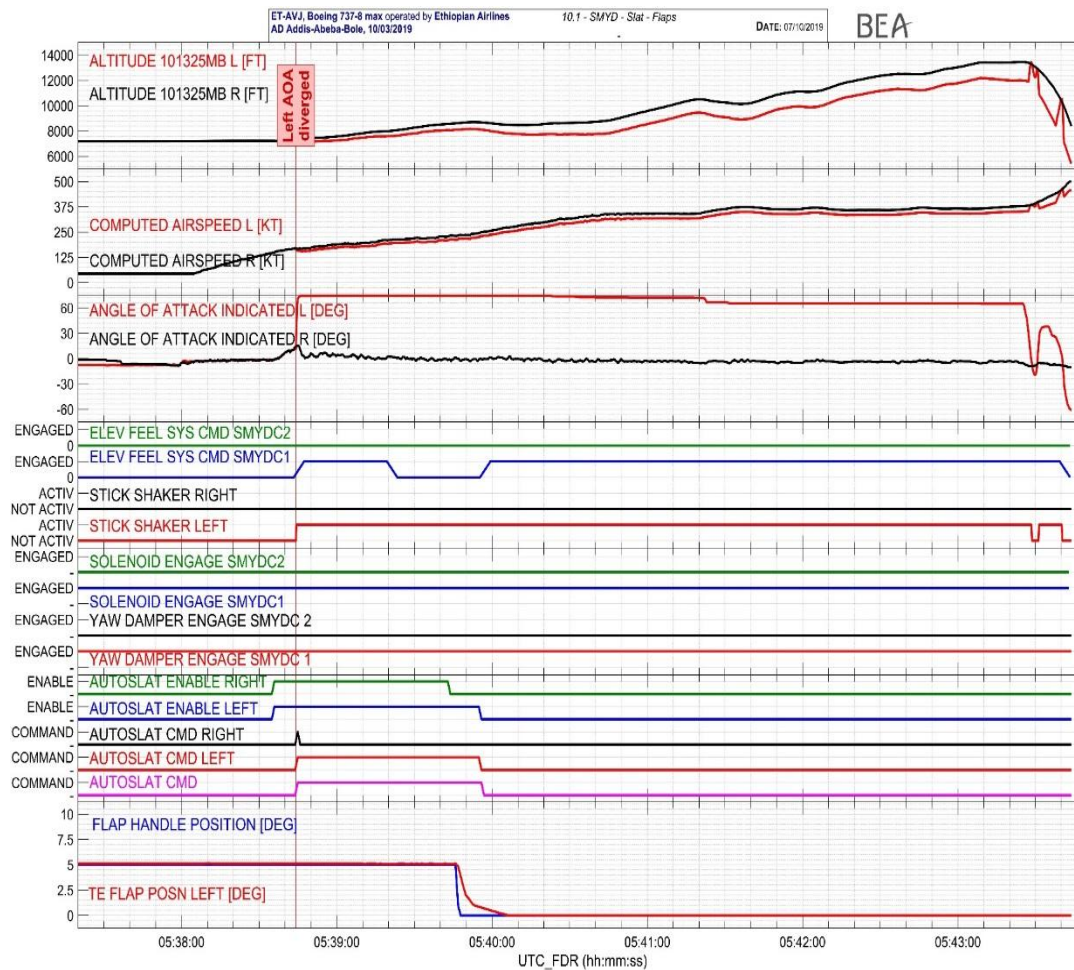
FIGURE63: AUTOSLAT, LEFT STICK SHAKER AND ELEVATOR FEEL SYSTEM

- the autoslat system triggered (SMYDC 1),
- the LH stick shaker engaged
- the LH elevator feel shift triggered.

At 5 h 39 min 56 s, the autoslat system stopped and the flap handle was at 0 position and flaps were moving up (flaps position lower than 1) with LH computed airspeed values reaching 230kt and RH computed airspeed value 250kt.

At 5h 39 min 44s SMYDC-2 disabled the RH autoslat function due to the RH computed airspeed (230kt reached). SMYDC1 disabled the LH autoslat function 12 s later due to the invalid LH computed airspeed.

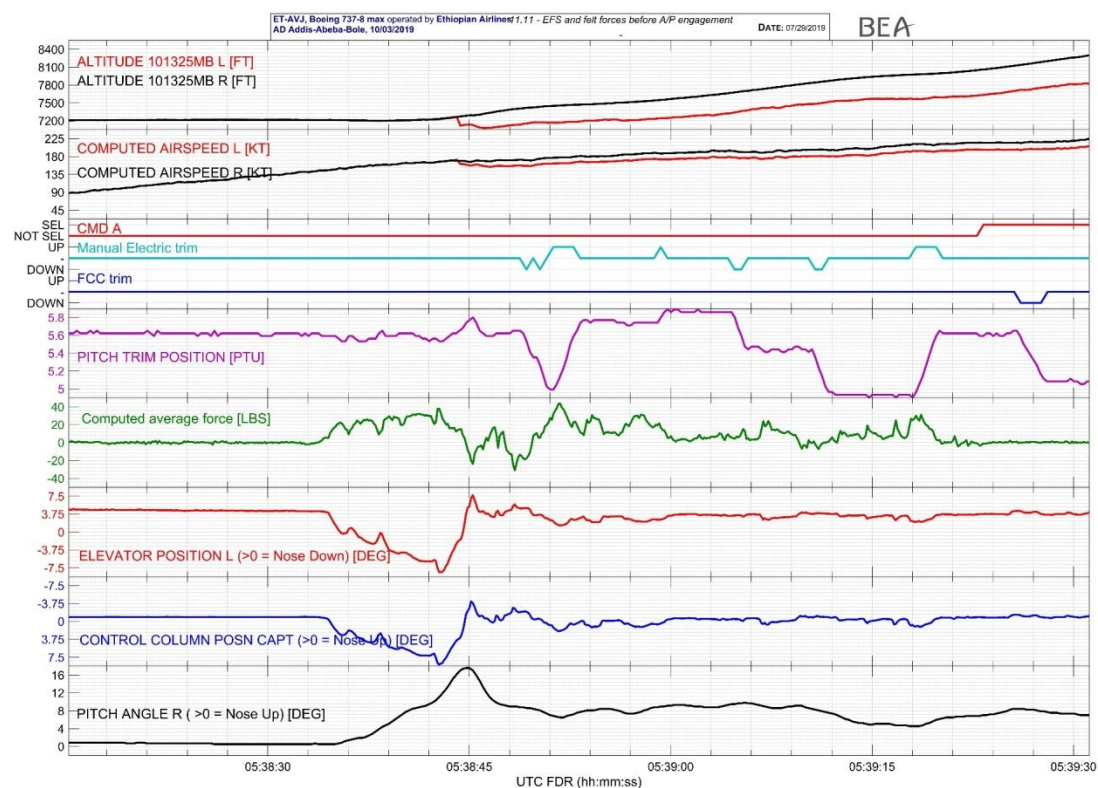
FIGURE 67: FORCE BEFORE A/P ENGAGEMENT

Before the A/P engagement, the recorded low force level underlined an airplane rather properly trimmed in pitch. At that time, the stabilizer position was 5.62 units (nose up setting) and the elevators position was of 3.5° (nose down setting).

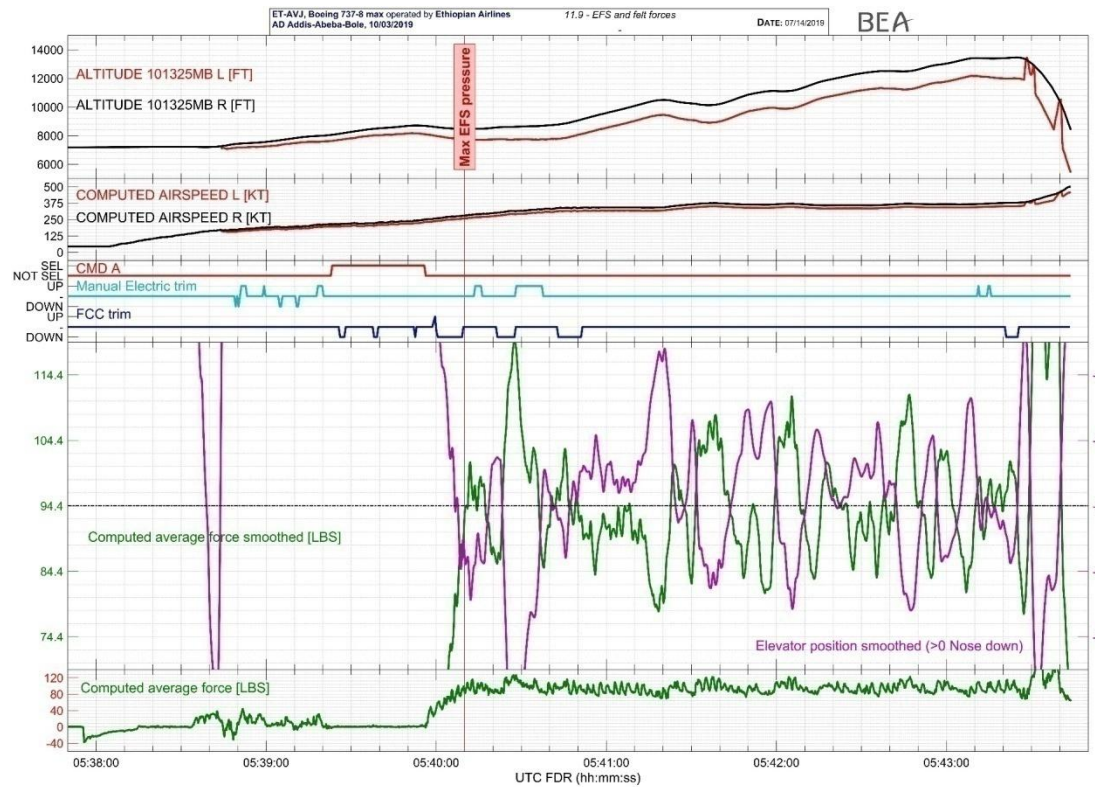
FIGURE 68: FELT FORCE AND ELEVATOR POSITION

Note1: the airplane manufacturer computed the pressure the elevator feel system delivered during the flight of the event. After the A/P disconnection, from the end of the 1st FCC trim down command until the end of the flight, the Elevator Feel system delivered a constant pressure that was the maximum pressure.

The gradient of force felt by the crew can be illustrated by the comparison between the force applied on the control column and the position of the elevator.

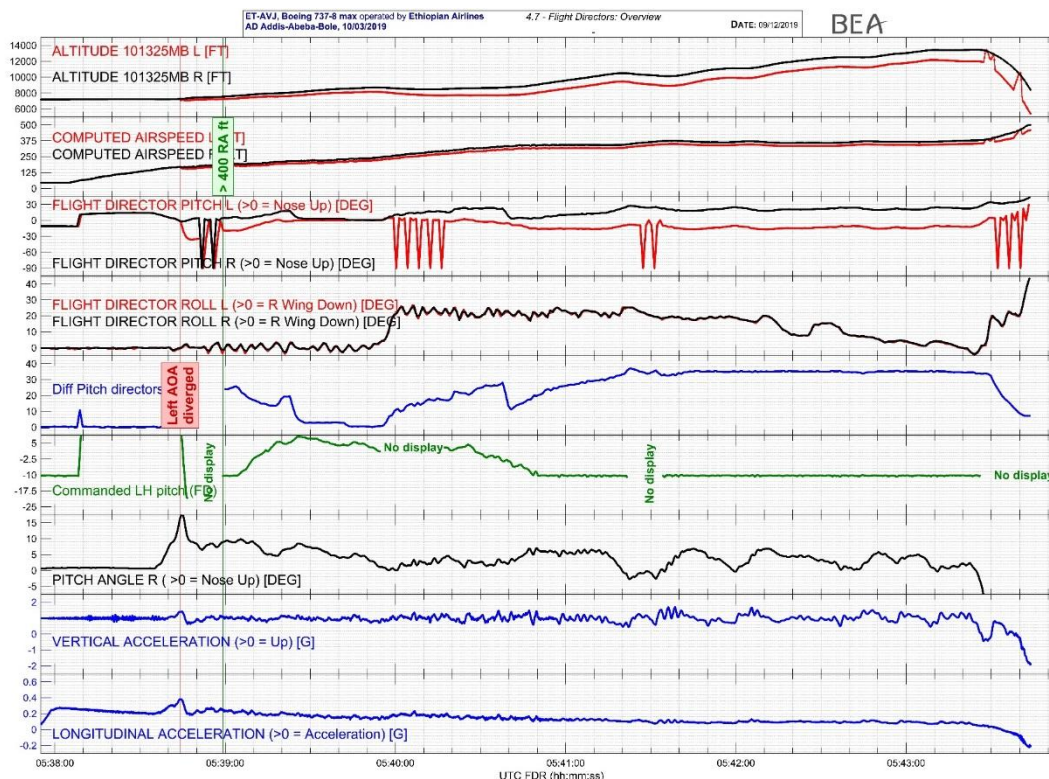
FIGURE 69: FLIGHT DIRECTOR DURING THE FLIGHT

Each time the LH or the RH invalidity pattern was recorded, the recorded invalidity code (NCD - No Computed Data) underlined a pitch F/D bar biased out of view.

Note: as the invalidity code was always NCD, the pitch command bar was only BOV. F/D flag did not trigger during the whole flight of the event.

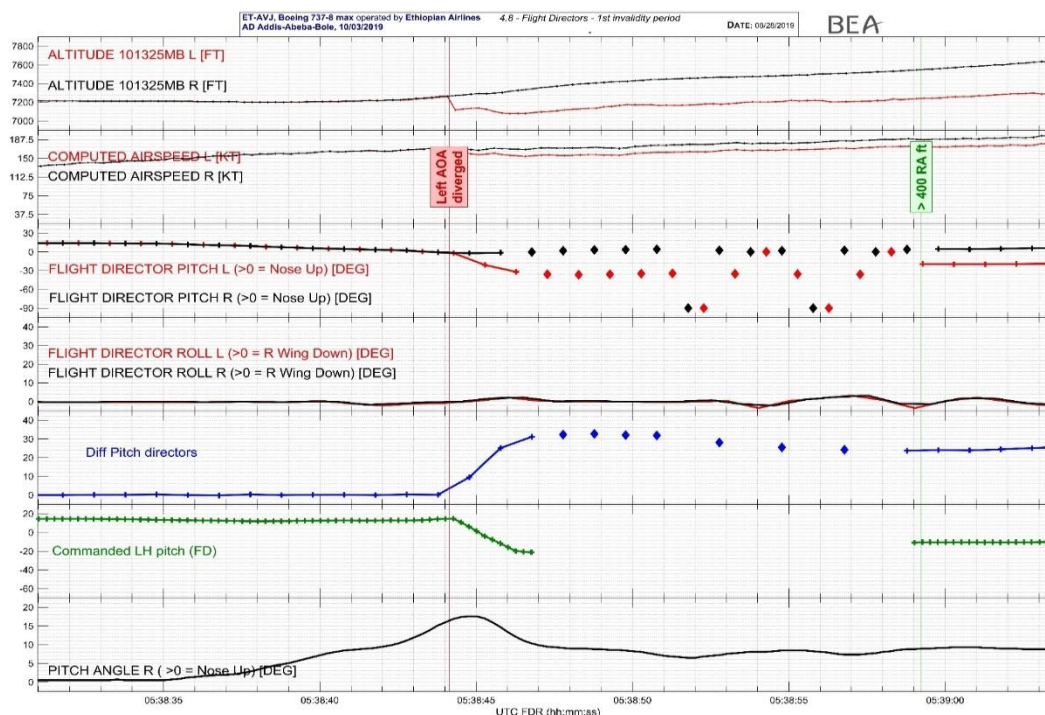
FIGURE 70: FLIGHT DIRECTORS - START OF THE FLIGHT

At the time of the 1st invalidity, F/D was in T/O mode and the radio altitude was lower than 400 ft.

When the LH and RH AOA values diverged, LH pitch F/D commands recorded values quickly decreased to -32° while RH pitch F/D recorded values slightly increased to -0.4° . The difference between LH pitch F/D values and RH pitch F/D values were greater than the threshold above which FCCs comparators triggers and both F/D pitch were biased out of view.

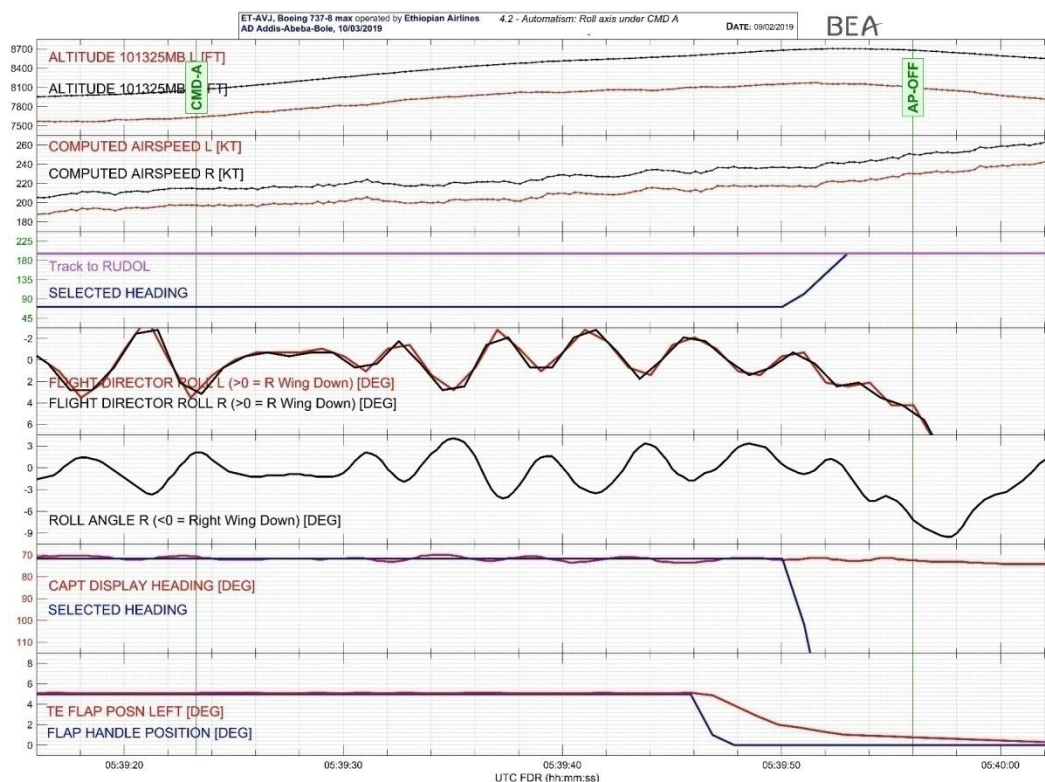
FIGURE 72: ROLL AXIS UNDER CMD A

The roll axis under CMD A behaved as expected:

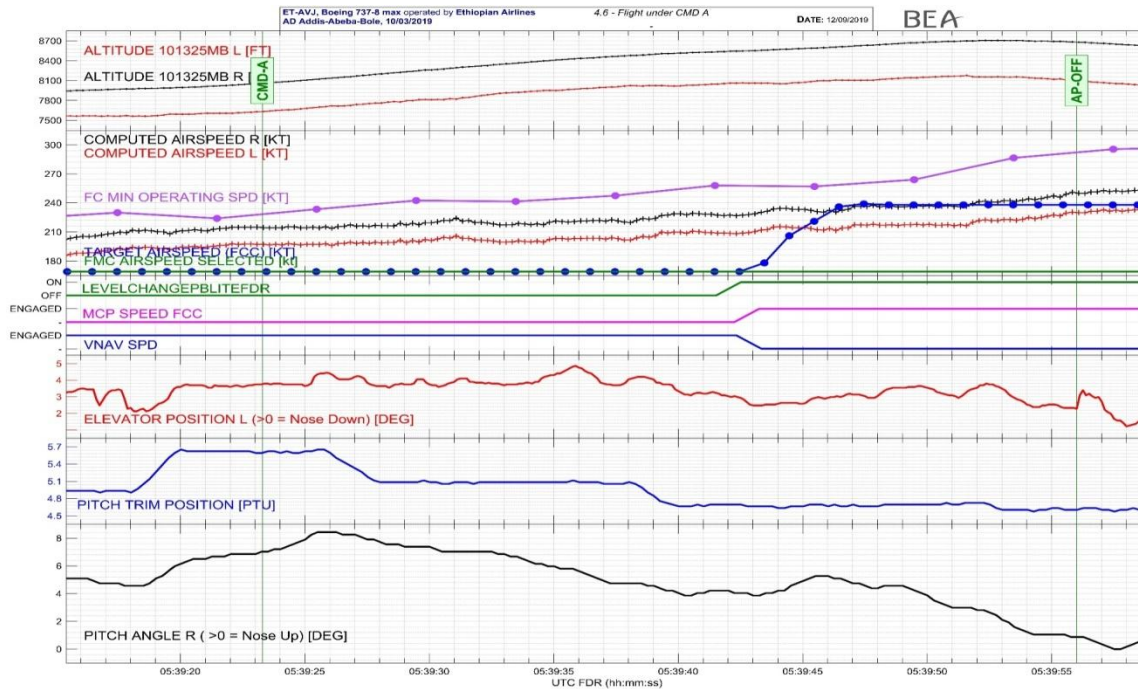
FIGURE 73: CMD A ENGAGEMENT

With the VNAV SPD mode engaged, the airplane was expected to climb towards the target altitude of the flight plan (32,000 ft) at a speed close to the FMC target airspeed.

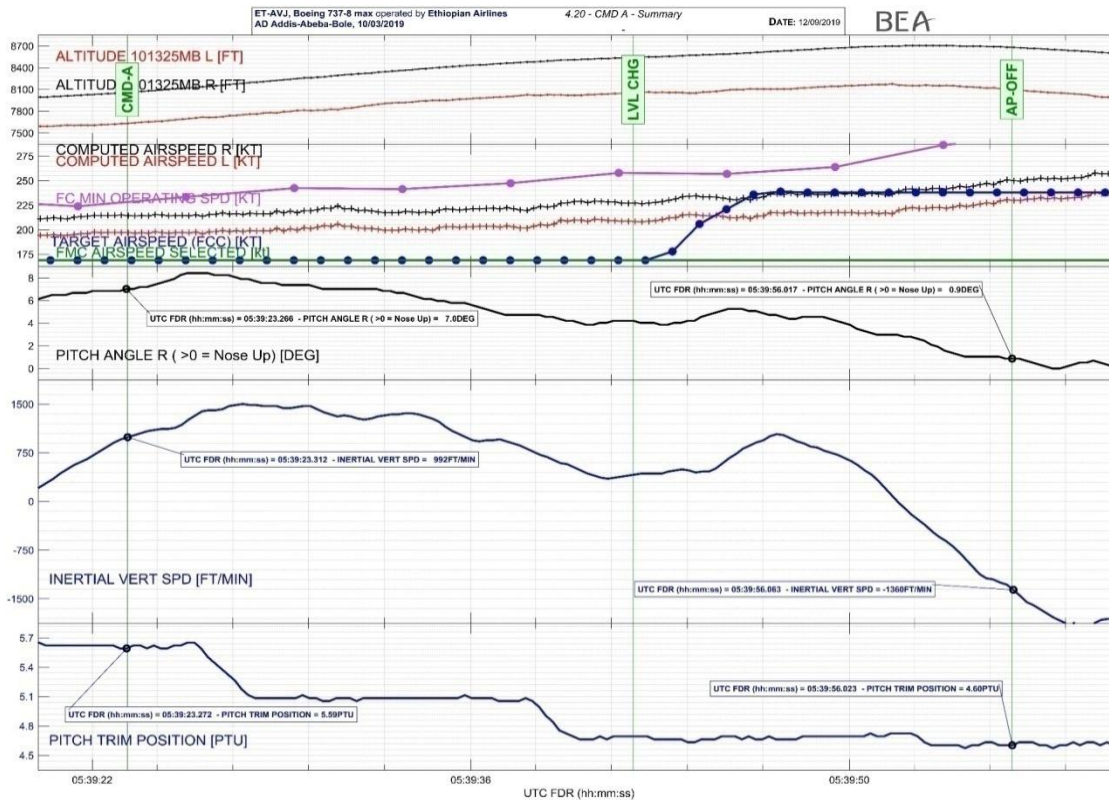
FIGURE74: CMD A - SUMMARY

At the connection of CMD A, the airplane was climbing with a vertical speed of around 1,000 ft/min increasing, a pitch value of around 7° increasing and a stabilizer position of 5.6 units.

When CMD A automatically disconnected, the airplane was descending with a vertical speed of around -1,400 ft/min, a pitch angle of around 1° and a stabilizer position of 4.6 units.

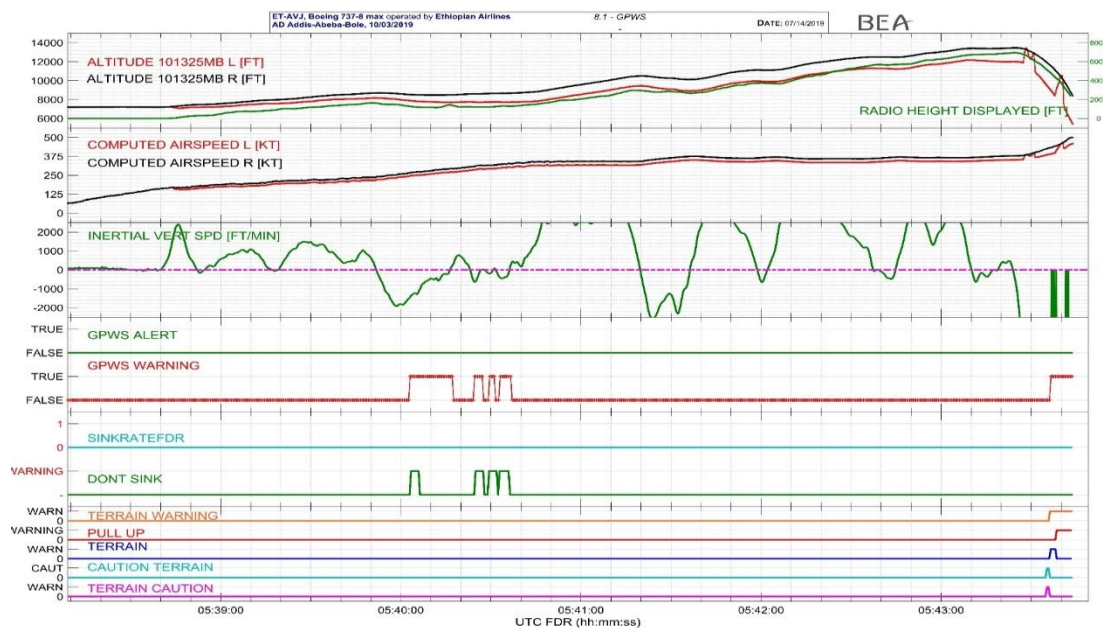
FIGURE 76: GPWS ALERTS

During all these alerts, the 'PULL UP' message should have been displayed on both PFD.

At the end of the flight, the combination of the vertical speed and the height of the airplane made the terrain and pull up warning trigger.

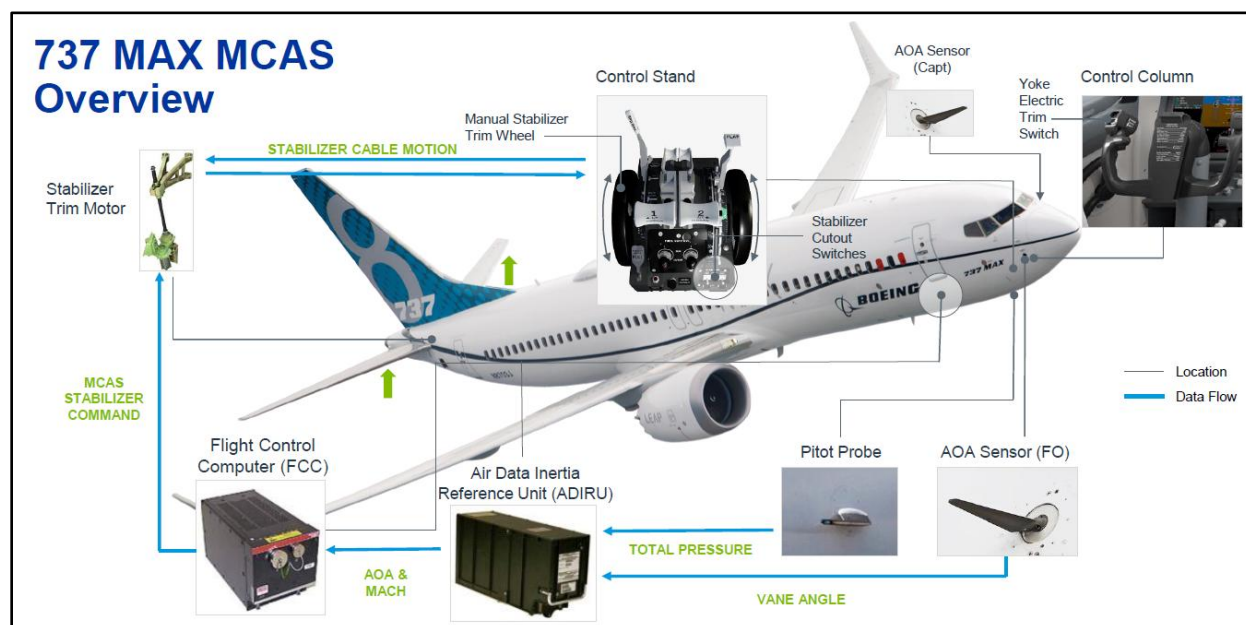
FIGURE 81: MCAS OVERVIEW

As originally delivered, the MCAS became active during manual, flaps-up flight (autopilot not engaged) when the AOA value received by the master FCC exceeded a threshold based on Mach number. When activated, the MCAS provided a high rate automatic trim command to move the stabilizer AND. The magnitude of the AND command was based on the AOA and the Mach. After the non-normal maneuver that resulted in the high AOA, and once the AOA fell below a reset threshold, MCAS would move the stabilizer ANU to the original position and reset the system. At any time, the stabilizer inputs could be stopped or reversed by the pilots using their yoke-mounted electric stabilizer trim switches, which also reset the system after a 5 second delay.

The latter behavior is based on the assumption that flight crews use the trim switches to completely return the airplane to neutral trim. In the FCC software version current at the time of the accident, if the original elevated AOA condition persists for more than five seconds following an MCAS flight control law reset, the MCAS flight control law will command another stabilizer nose down trim input (with the magnitude based on the AOA and Mach sensed at that time).
